# Manhole Inspection Summary

Manhole # S25EE\_020MH

Insp Date: **9/29/07 9:11 AM**

**Location** Address: **PENNSYLVANIA AVE**

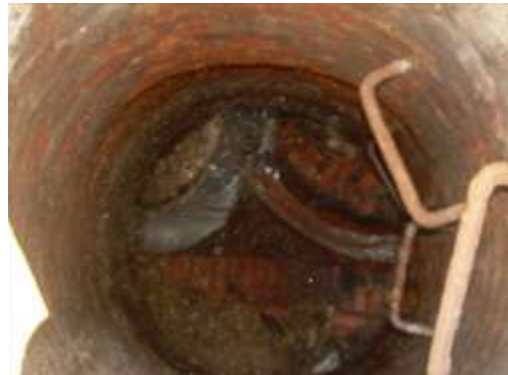
Top View

Corroded steps. Evidence of surcharge - Bench debris.

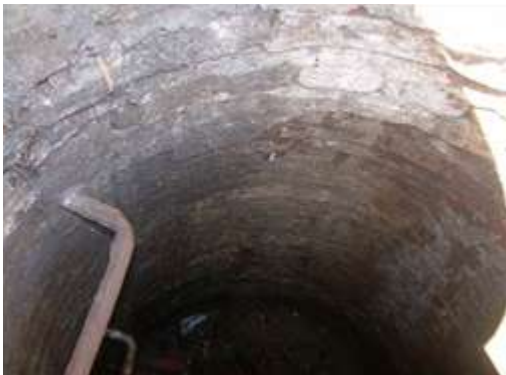
Defect

Adjustment deterioration and infiltration. Corbel infiltration.

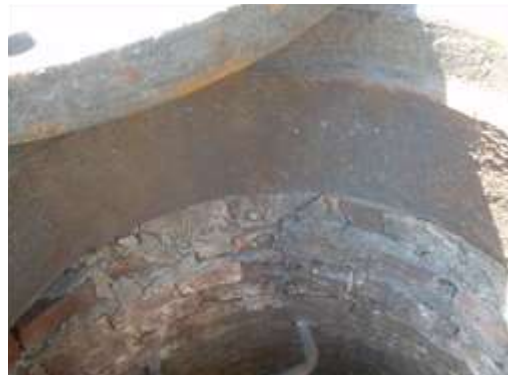
Defect

Frame leaks. Adjustment deterioration and infiltration. Corbel infiltration.

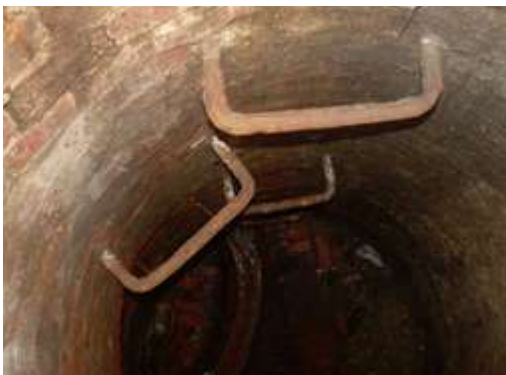
Defect

Corroded steps. Corbel infiltration.

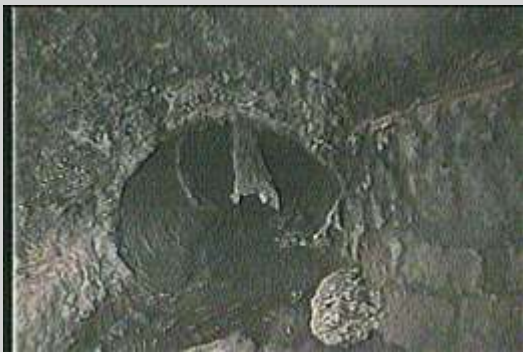
### 10 in. Circular Gravity Sewer Pipe Out @ 12 O'Clock

Deposits: ☐ None ☒ **Mud** ☐ Sludge ☐ Debris ☒ **Grease**

Silt Depth: **0.5** (in.) Deposits Extent: **Light**

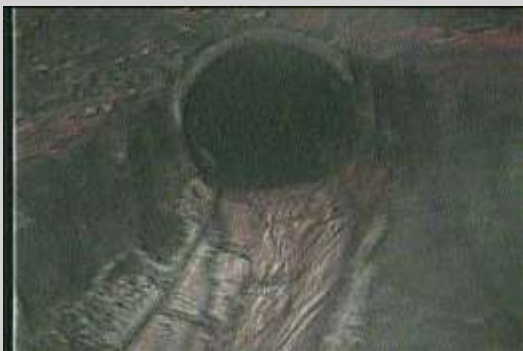
### 8 in. Circular Gravity Sewer Pipe In @ 3 O'Clock

Infiltration: **Evidence** Pipe Seal Cond: **Cracked**

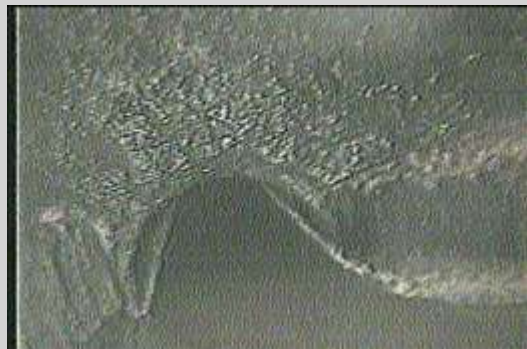
8 in. Circular Gravity Sewer

Deposits: ☐ None ☐ Mud ☐ Sludge ☐ Debris ☒ **Grease**

Deposits Extent: **Light**
